✓
AFML-TR-72-30

INSTALLATION OF A SELF-SEALING MATERIALS
SYSTEM IN A C-130 INTEGRAL FUEL TANK WING

Northrop Corporation
Aircraft Division

September 1972

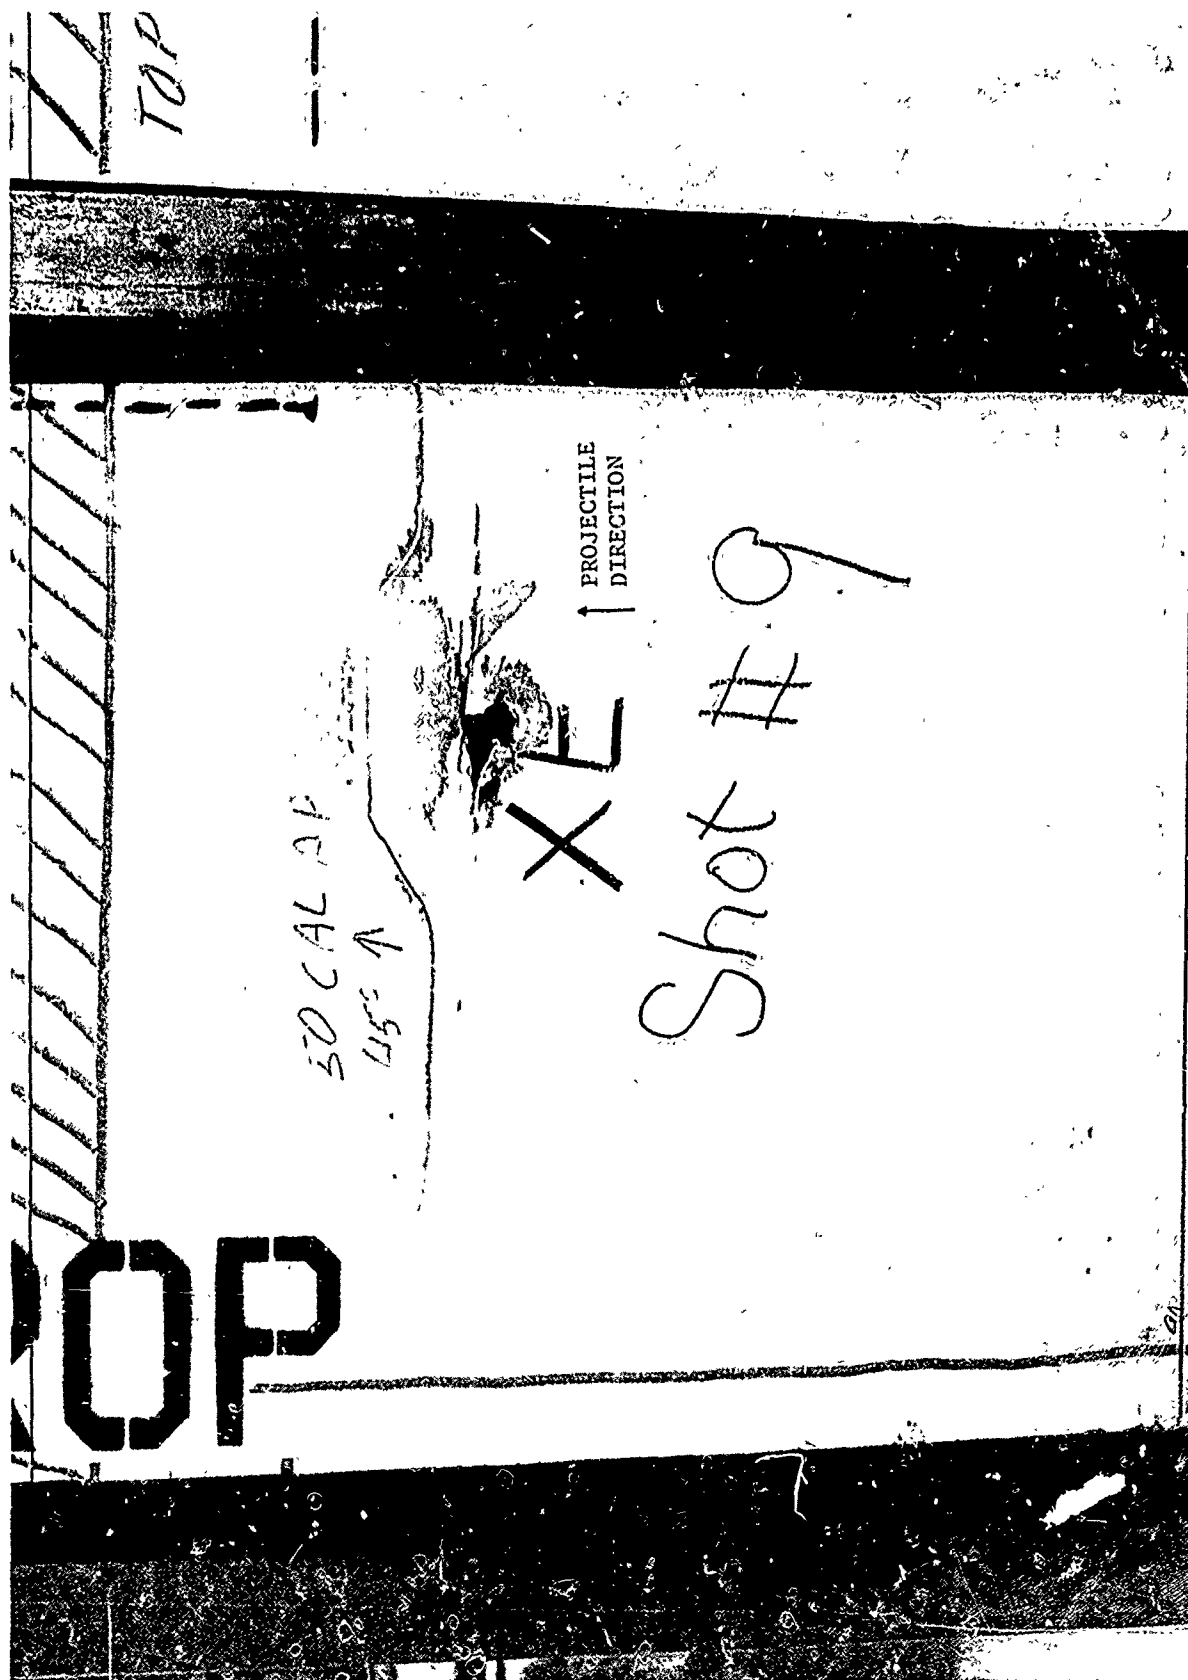
FIGURE 71. TEST NO. 9, .50 CALIBER AP 45° FROM VERTICAL -
ENTRY FACE OF THE TANK

For comparison purposes, a .50 caliber AP projectile was fired into Bay 8 (area X E) which did not contain any protection. That is, no damage control or self-sealing systems had been installed in this part of the tank. The projectile impacted the tank in a 45° angle of incidence. Figure 70 shows the fuel leakage immediately after impact. The leakage was too heavy to be measured. The damage at the tank entry metal skin is shown in Figure 71. A hole 2 1/4-inch X 3/4-inch and two cracks (6 inches and 16 inches long) were provoked as shown in the figure. Upon penetration of the tank entry wall, a rib was hit. At the exit side of the tank, the tumbling projectile hit two ribs including one with rivets. A 5-inch x 2 1/2-inch piece of metal was removed and there were cracks in the skin around the hole (See Figure 72).

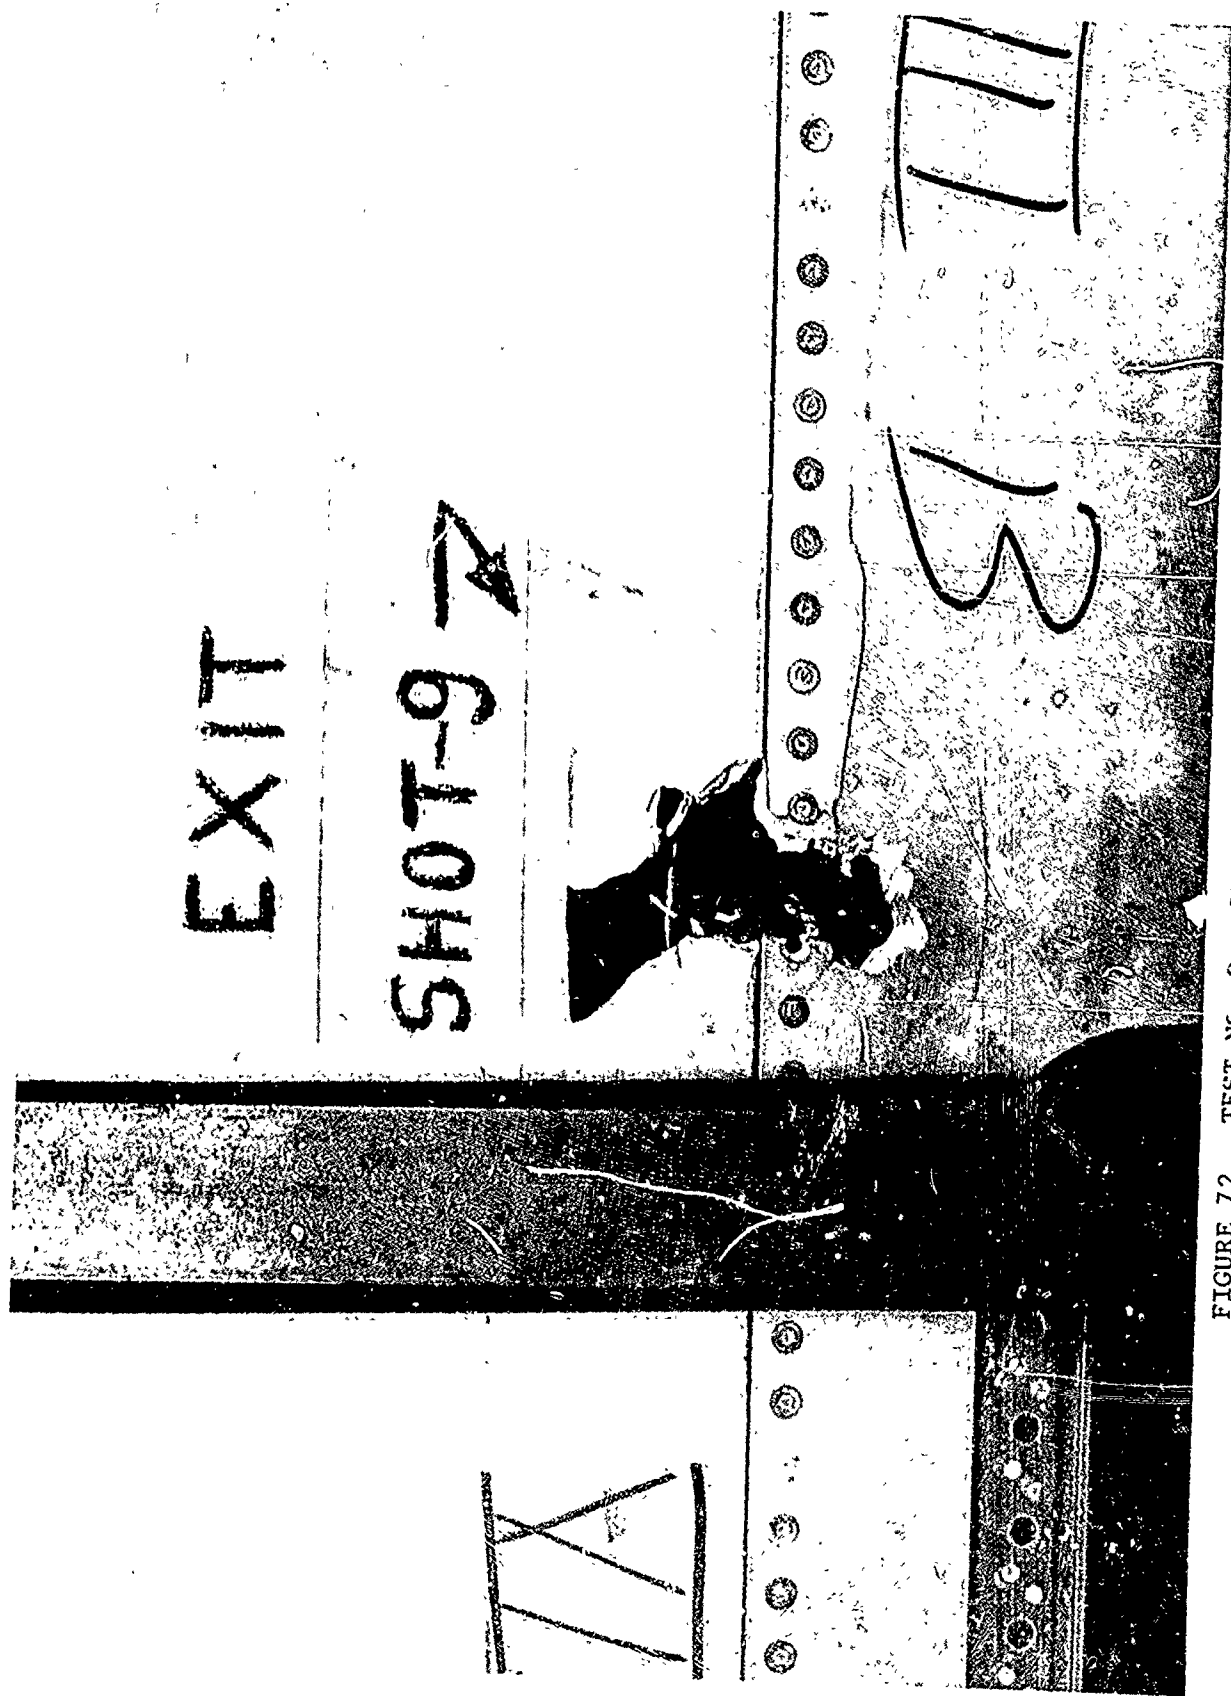
FIGURE 72. TEST NO. 9, .50 CALIBER AP, 45° FROM VERTICAL
EXIT FACE OF THE TANK

Although the damage caused by this projectile impact was extensive, it would have been greater had the tank been $2/3$ full of fuel. It is not known how much fuel remained in the tank when this shot was fired, but a substantial amount of fuel was noted to have escaped through the wounds of previous shots; consequently, destructive hydraulic ram pressure waves as intense as those created by previous projectile impacts could not have been produced in this instance.

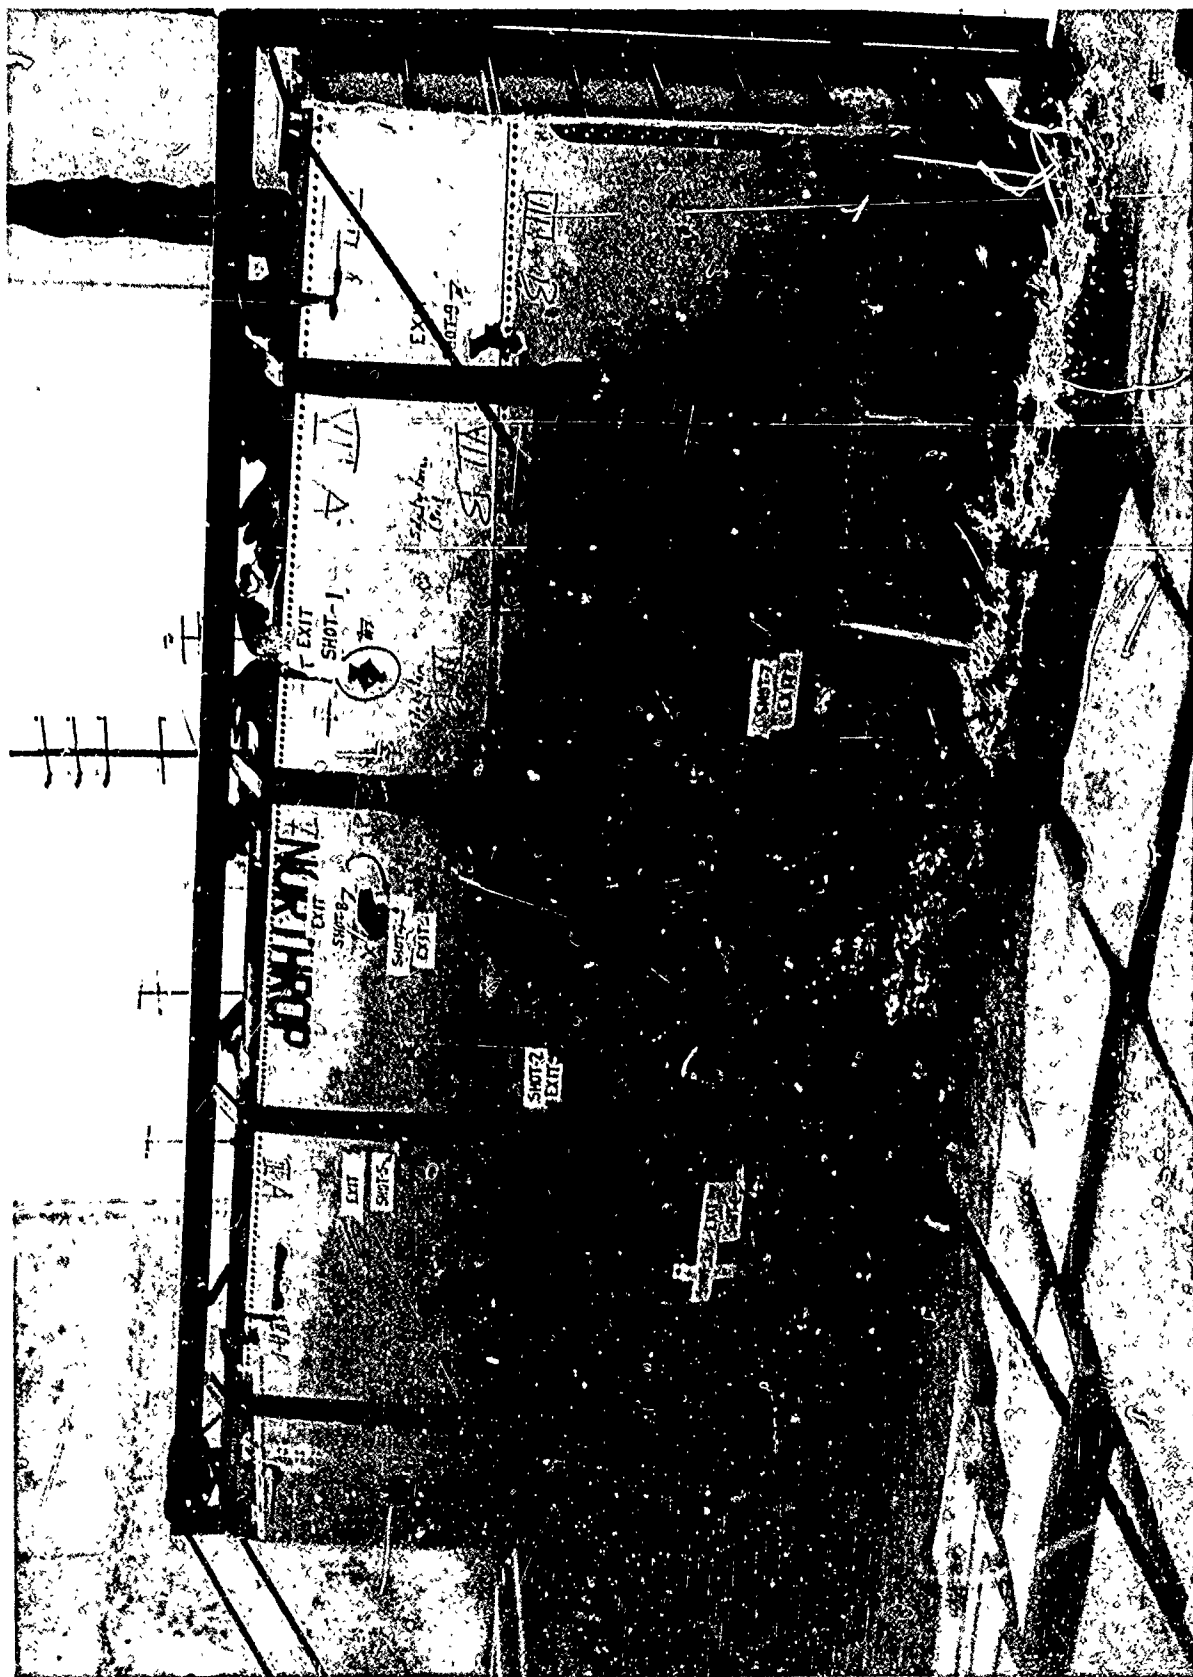
FIGURE 7. GENERAL VIEW OF TANK EXIT SIDE AFTER COMPLETION OF TESTS

A general view of the tank exit wall is given in Figure 73. This shows the damage provoked by all nine firing tests described above.
